Manhole Inspection Summary

Manhole # S35WW_032MH

Insp Date: **1/9/07 11:40 AM**

Location Address: **305 31ST ST**

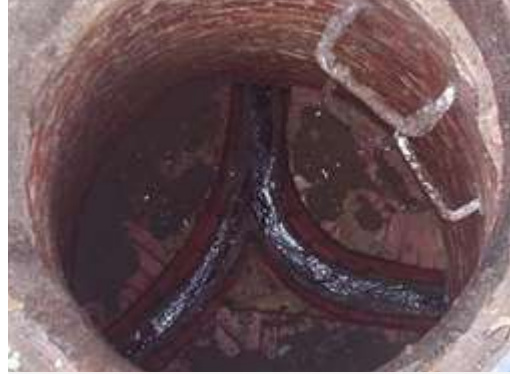
Top View

☒ **Debris** (not Condition related)

☒ **Corroded**

☒ **Evidence Of Surcharge**

Corroded steps. Evidence of surcharge - Bench debris.

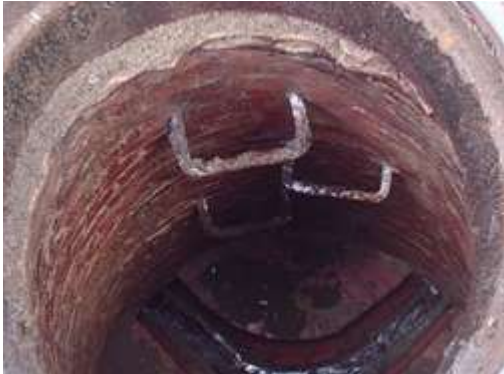
Defect

☒ **Leaks**

Condition: ☐ Sound ☐ Cracked ☐ Root Intrusion ☐ Loose Brick ☒ **Deteriorated**

Infiltration: ☐ None ☒ **Joint** ☐ Cracks ☐ Mortar ☐ Roots ☒ **Wall**

Infiltration: ☐ None ☐ Joint ☐ Cracks ☐ Mortar ☐ Roots ☒ **Wall**

Frame leaks. Frame offset. Adjustment deterioration and infiltration. Corbel infiltration.

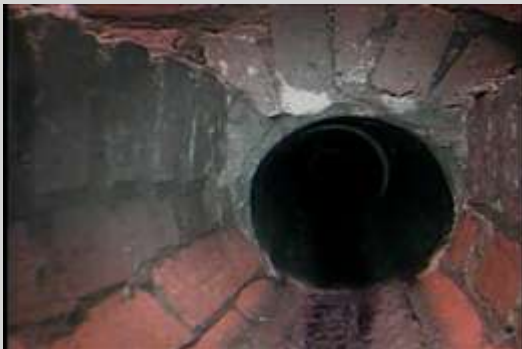
8 in. Circular Gravity Sewer Pipe In @ 3 O'Clock

Infiltration: **Evidence** Pipe Seal Cond: **Unknown**
